# Typical damages at wind turbines – and their prevention

Presentation at the COWEC 2013  
18.06.2013

Dipl.-Ing. / Dipl.-Wirt.-Ing. Swen-Olaf Teichgräber  
Dipl. Ing; öbuv SV Jürgen Holzmüller  
8.2 Ingenieurbüro Holzmüller

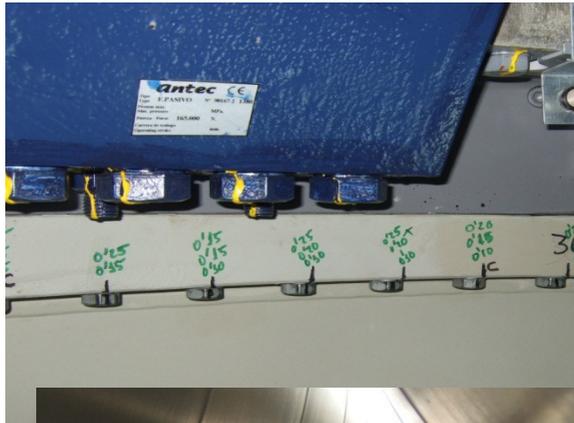
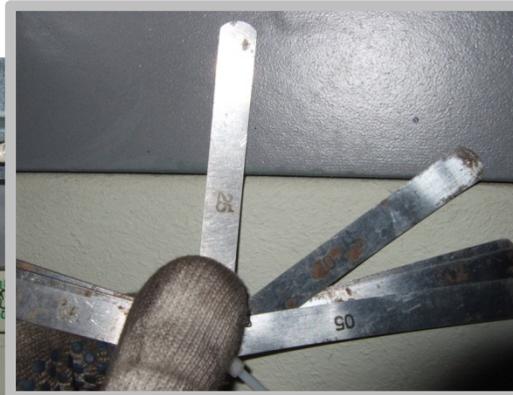
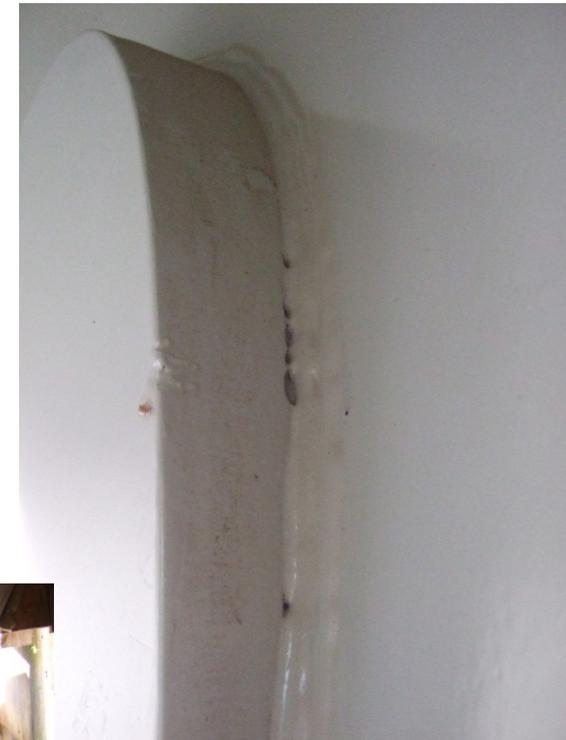
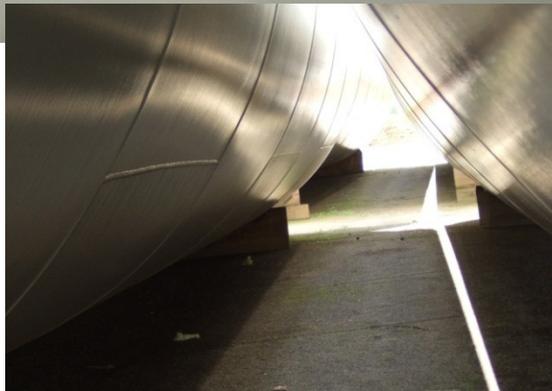
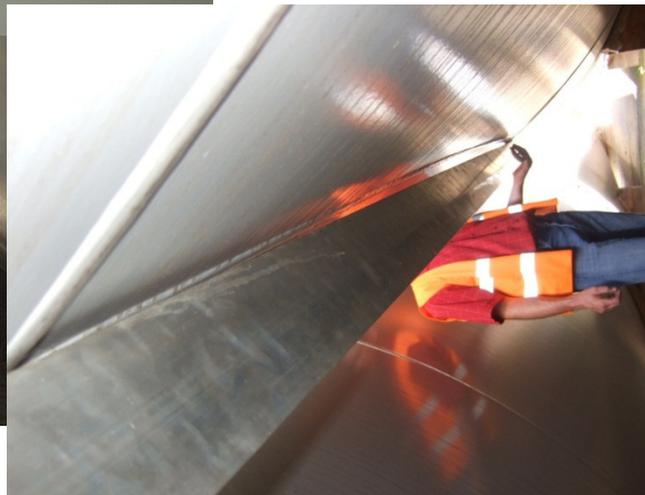
- tilting gaps between top flange and yaw bearing
- Buckles in tower shell plates
- Notches in weldings

- quality control: poor / no measurements of flange flatness
  - no consistent overall quality system (no performance figures)
  - remarks in the drawing („grind notch free“) have been ignored / overseen
  - steel cone has not been „calibrated“ after rolling;
  - wrong interpretation of “green stamped” drawings
  - missing supervision of the fabrication / workshop inspections
- >> Weak Q-system / lack in the procedures / lack in qualification

- shimming with plates; Regular exchange of bolts; weld repairs (offshore!)
- >> **extended O&M costs**
- cutting and replacing of one steel cone; Cutting and replacing of secondary items
- >> **Delay in shipment of several weeks, no healing after installation**

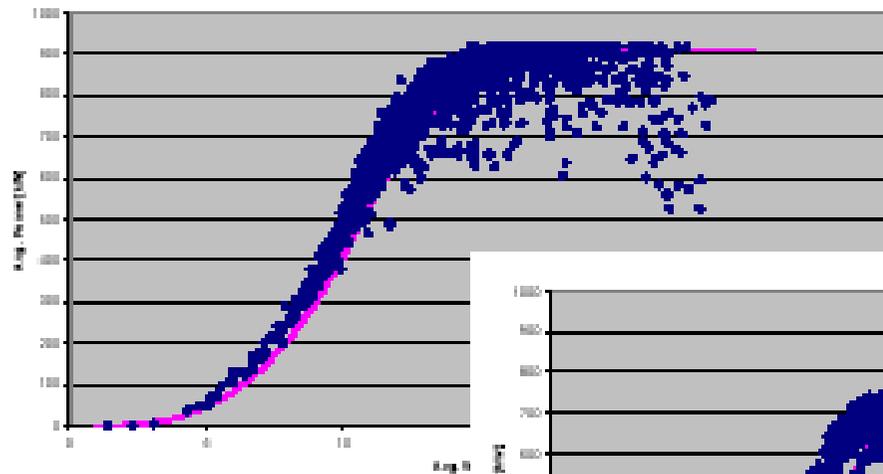
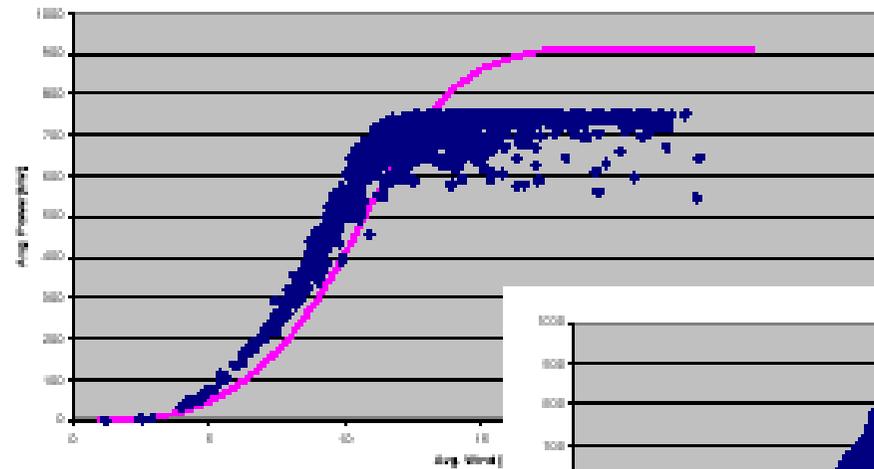
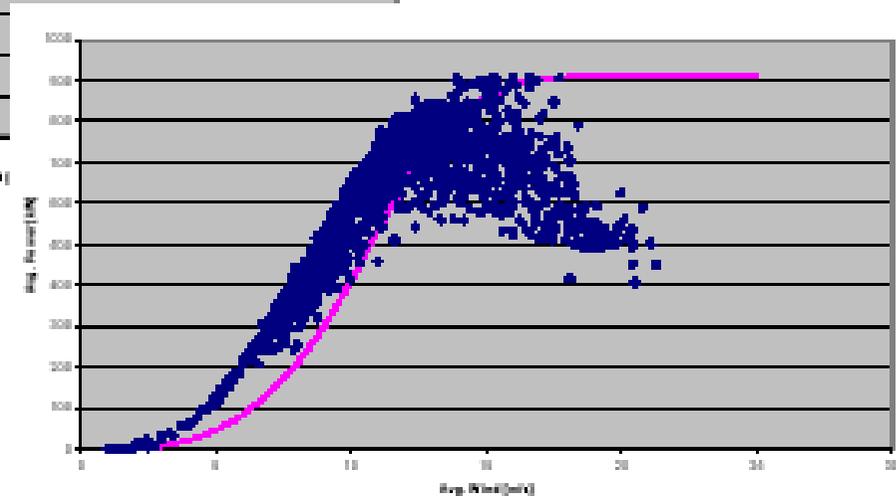
Different “power curves” in one wind farm (SCADA data)

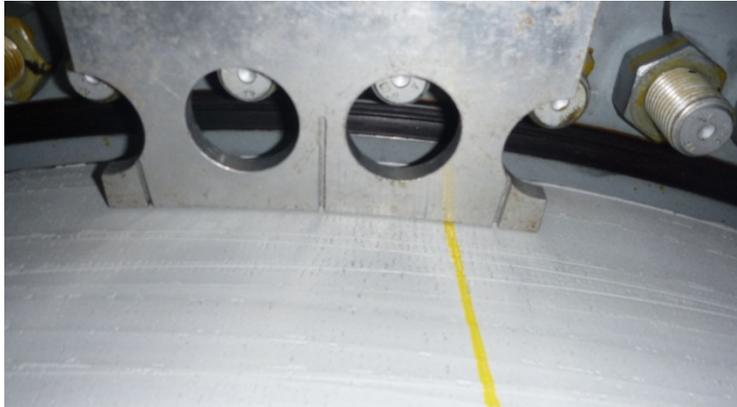
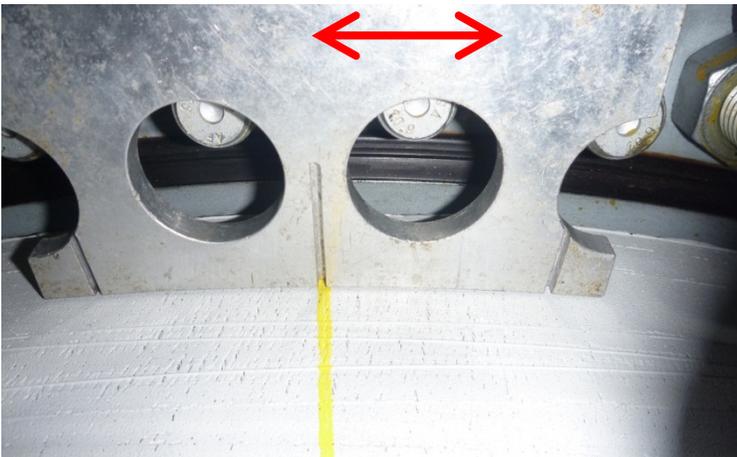
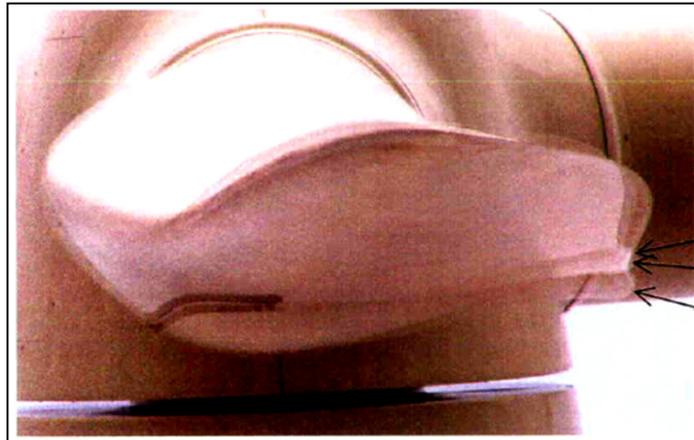
- misalignment of rotor blades cause aerodynamic imbalance
- displacement of one blade for one bolt during installation

Blatt LM 35.0P 41 :	0° (Ref)
Blatt LM 35.0P 32 :	-0,8°
Blatt LM 35.0P 40 :	-5,2°

- correction of blade position
- re-calculation of life time

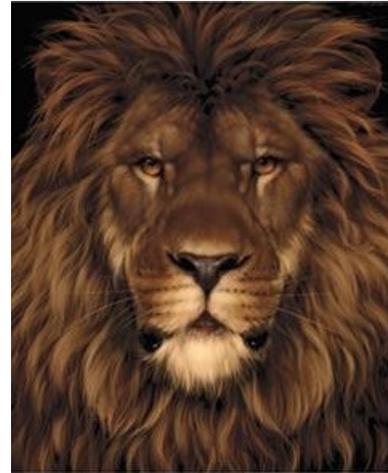
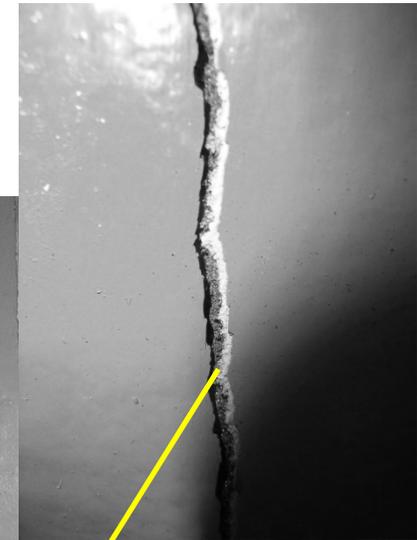
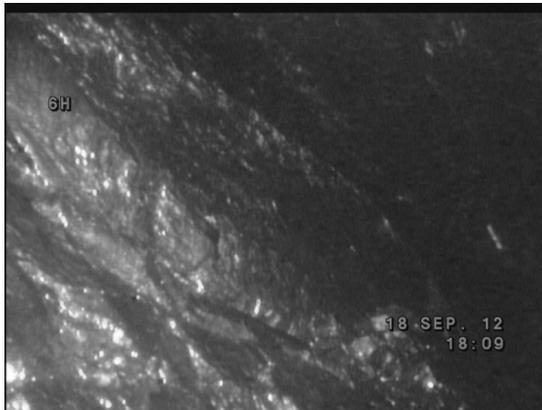
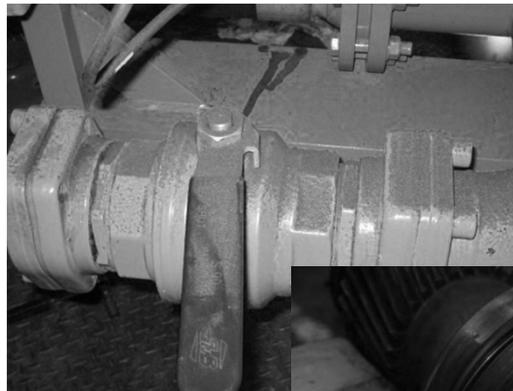
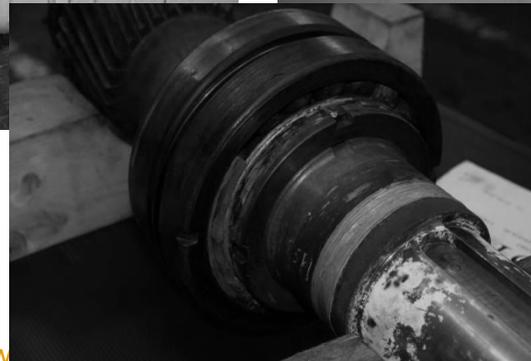
- Sudden rise of oil filter pressure
- Alarm of the fire-detector
- Alarm of the particle-sensor
- Alarm of the temp sensor
- “Shock” in the control room
- Sudden “death” of the WEC

besides the technical reasons behind which caused the damages, the installed CMS was not able to give an early alarm due to:

- systems were not cross linked
- systems were not connected to the WEC-Control system
- systems have not been monitored (manual data transfer)
- supervisors could not read the signs

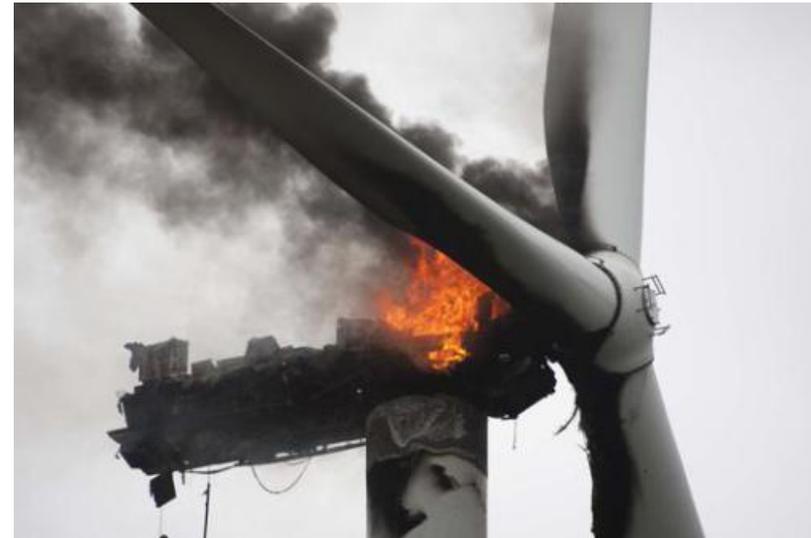
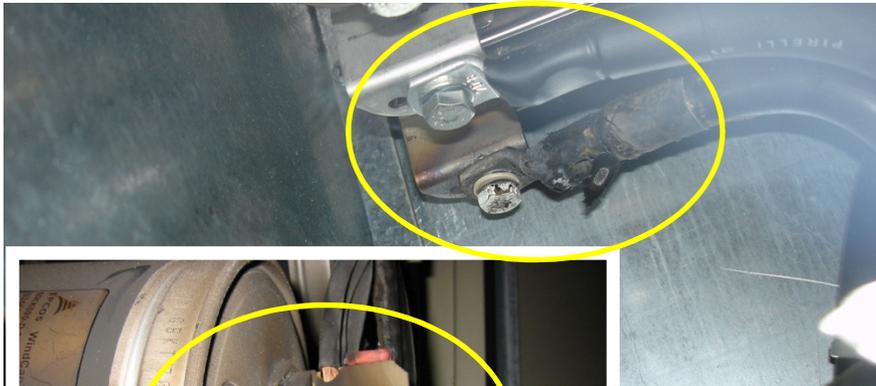
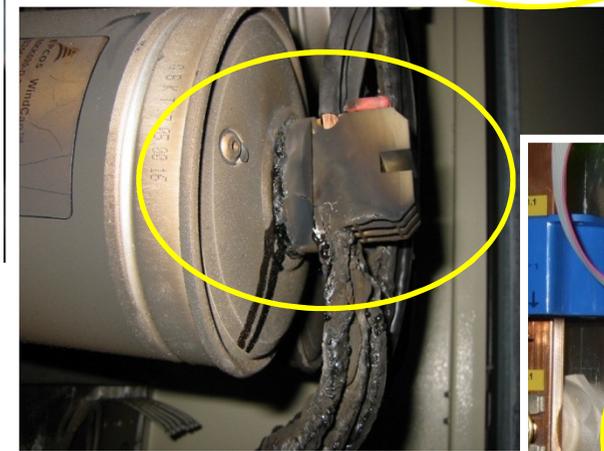
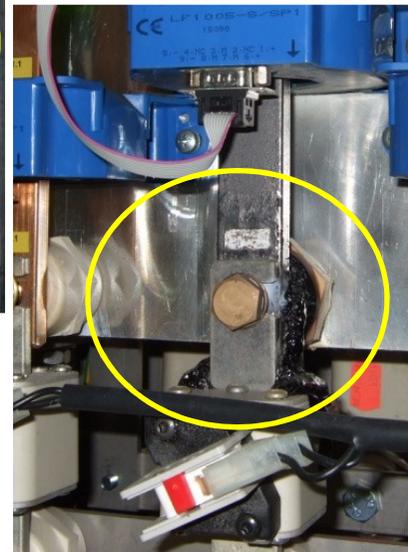
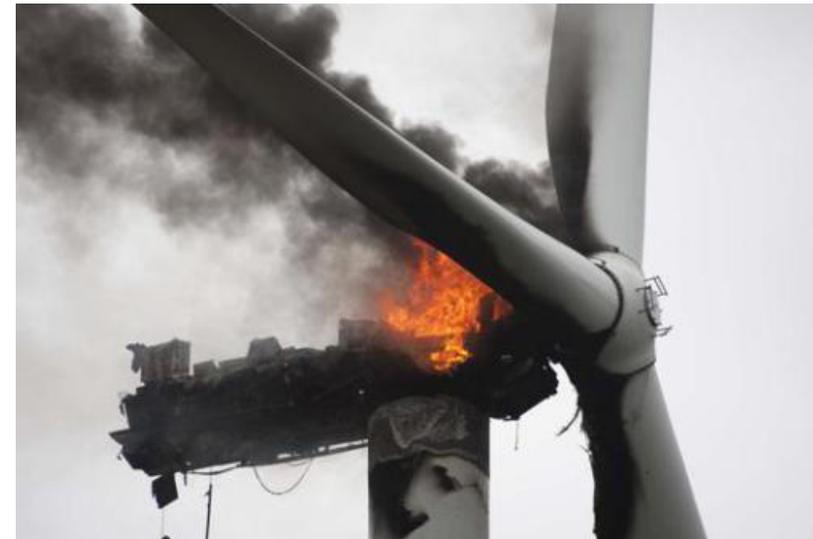
- Reason for most losses of complete turbines (newspaper research; 5-10/a)
- Some cases caused by lightning
- Several cases caused by electrical defects

- Electrical installation / cabinets contain many bolts
- Bolt torque can hardly be checked (very low values necessary)
- torque control may need a complete disconnection from the grid
- Cabinets are vibrating due to turbine operation, ventilators, etc.
