By Jürgen Holzmüller, Dietmar Obst, Jochen Ziehm and Rüdiger Kipke, 8.2, Germany

Damage on Wind Turbines

What is the Best Way to Assess This?

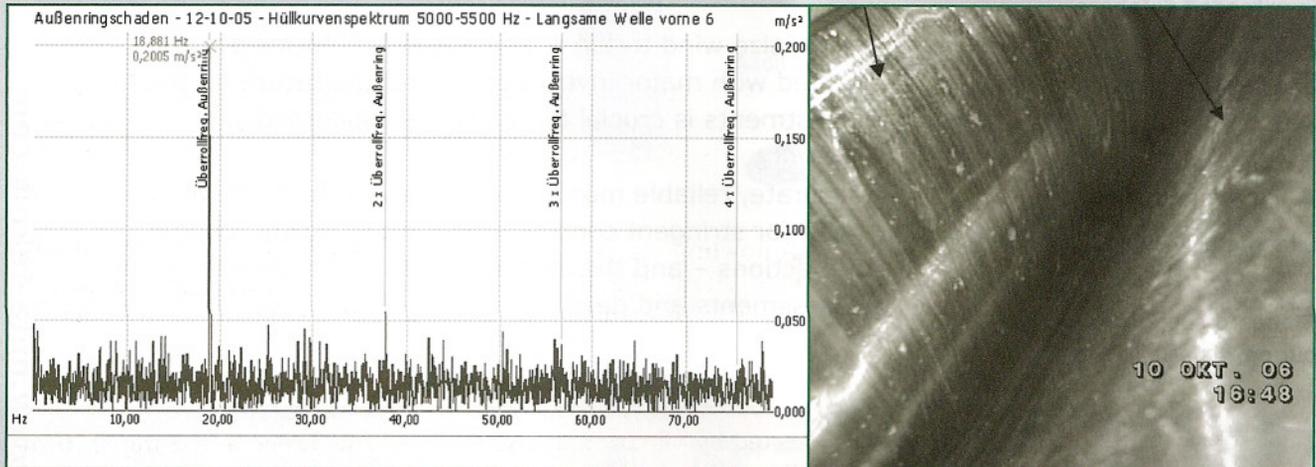
Case study 1: Bearing damage on the low speed shaft

Visual inspection and stethoscope:

No indication of any damage

Video endoscopy:

Damage category 'Alarm'

Vibration analysis:

Outer ring damage category 'Alarm'

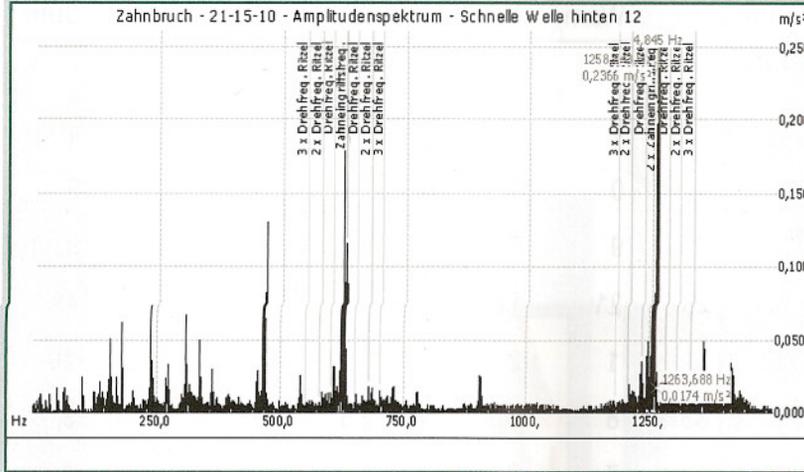
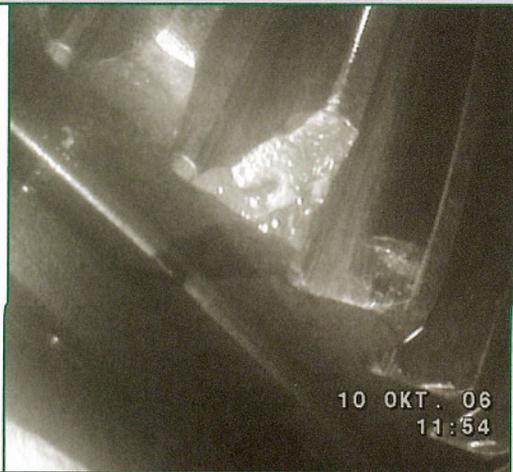
Case study 2: Broken teeth on the pinion of the high speed shaft

Visual inspection and stethoscope:
Video endoscopy:
Vibration analysis:

Damage category 'Warning'
Damage category 'Warning'
No noticeable problems

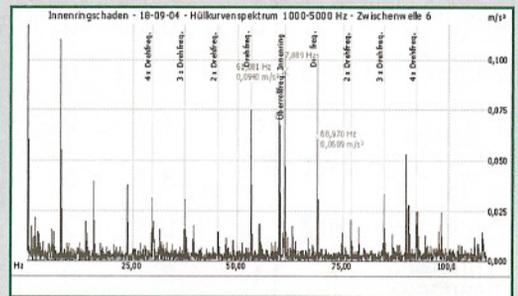
Case study 3: Damage on a bearing of the intermediate shaft

Visual inspection and stethoscope:
Video endoscopy:
Vibration analysis:

No noticeable problems
No noticeable problems (bearing not accessible)
Damage category 'Warning'

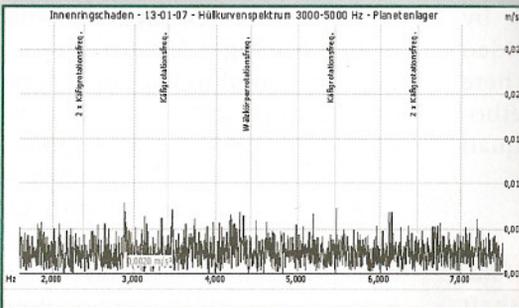
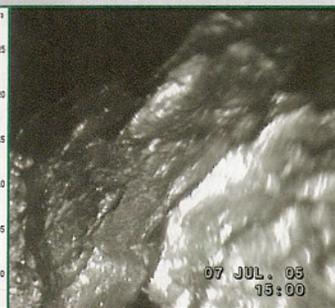
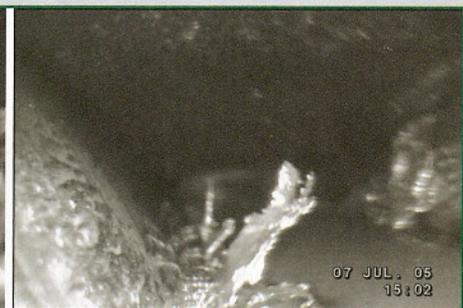
Case study 4: Damage on a planetary bearing

Stethoscope:
Video endoscopy:
Vibration analysis:

No noticeable problems
Damage category 'Alarm'
No noticeable problems
