## Error statistics for the gearbox in drive trains of WEC

Dipl.-Ing. Jürgen Holzmüller

8.2 Ingenieurbüro Holzmüller Aurich, Julianenburger Straße 19a, D - 26605 Aurich

by Jürgen Holzmüller, 8.2 Office Aurich

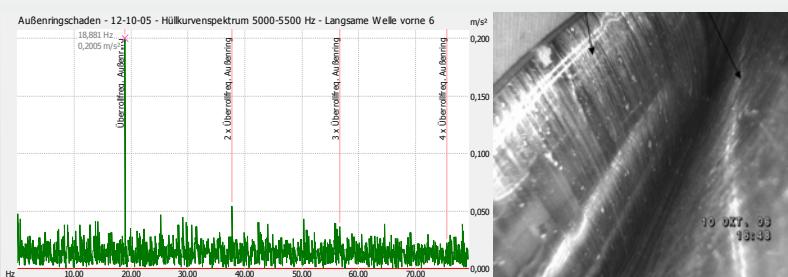
## Exemplary Case 1: bearing damage

### Damage of outer ring / LSS

Visual inspection & Stethoscope: no indication of damage

Videoendoscopy: damage of category 'Warning'

vibration analysis : damage of category 'Warning'

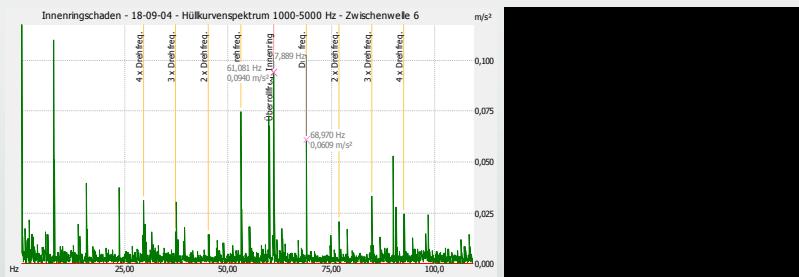
## Exemplary Case 2: bearing damage

### Damage of inner ring / bearing MSS

Visual inspection & Stethoscope: no indication of damage

Videoendoscopy: no access to the bearing

vibration analysis : damage of category 'Warning'

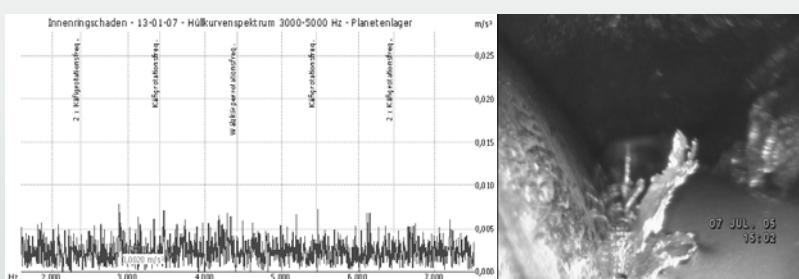
## Exemplary Case 3: bearing damage

### Damage at planetary wheel

Visual inspection & Stethoscope: no access to the bearing

Videoendoscopy: damage of category 'Alarm'

vibration analysis: no indication of damage

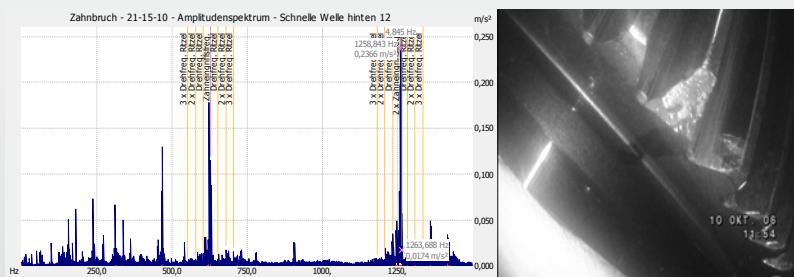
## Exemplary Case 5: gear damage

## **Damage at gear / HSS**

Visual inspection & Stethoscope: damage of category ,Warning'

Videoendoscopy: damage of category 'Warning'

vibration analysis : no indication of damage
